**ASSESSMENT REPORT:
INVENTORY OF HISTORIC ARTIFACTS FROM THE MISSION CONTROL CENTER,
CAPE CANAVERAL AIR FORCE STATION, BREVARD COUNTY, FLORIDA**

Prepared for:
John F. Kennedy Space Center
Environmental Management Branch
Kennedy Space Center, Florida

Prepared by:
Archaeological Consultants, Inc.
8110 Blaikie Court, Suite A
Sarasota, Florida 34240

May 2009

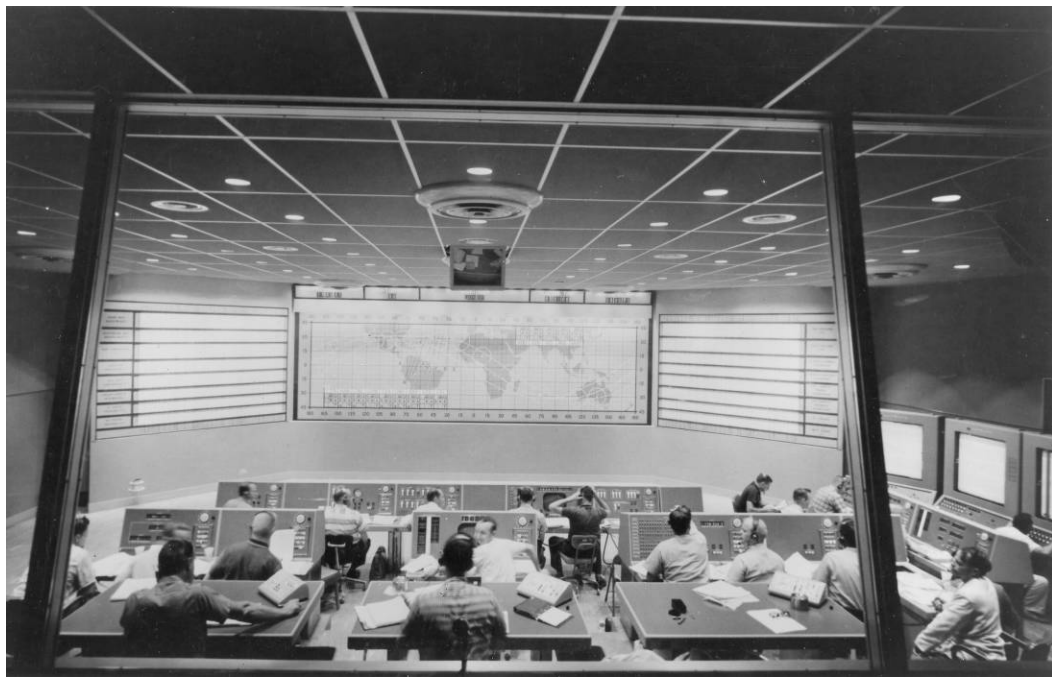
Photo 2. Mission control room during MR-3, May 1961

(Source: NASA 61-MR3-95). *Note placement of consoles and desks, world map, trend charts, plot boards, and pattern of ceiling lights, HVAC fixtures, and small audio speakers.*

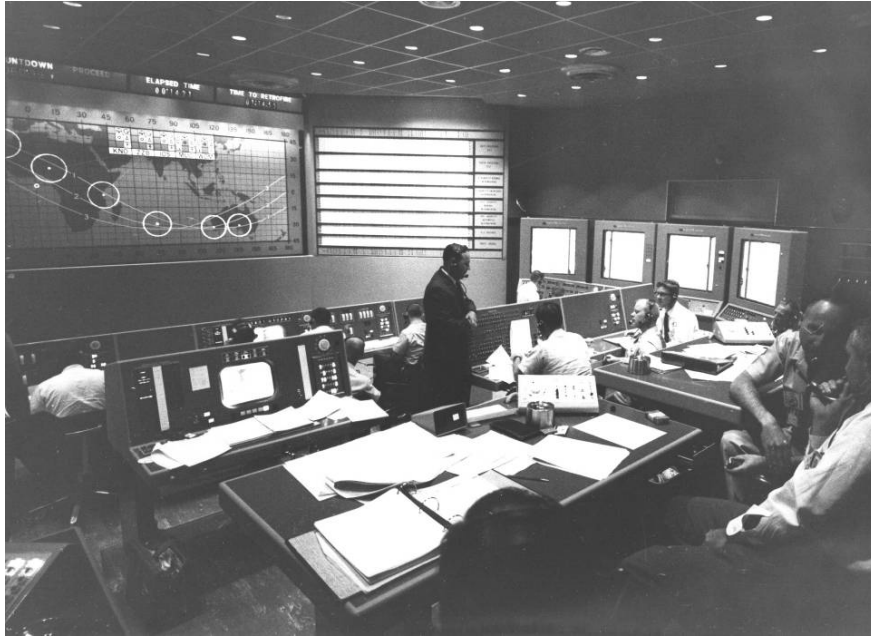
Photo 3. View (undated) of the mission control room during Project Mercury (Source: NASA P-06436). *Note the four plot boards on left side of room, world map with circles depicting tracking stations, and trend charts to the right of the world map. Also note three orbital paths on the world tracking map.*

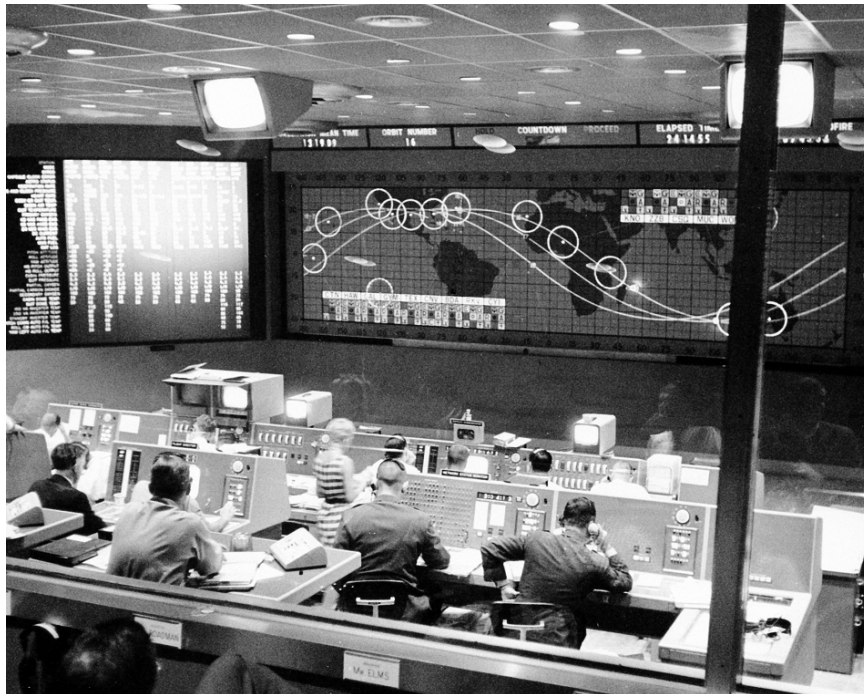
Photo 5. Mission control room during MA-9, May 1963

(Source: NASA 63-MA9-164). *Note new rear projection panel, that replaced the trend charts, flanking the world map.*

Following the Mercury mission (MA-8) in October 1962, modifications to the MCC were initiated to support the upcoming Project Gemini. Among the changes was the replacement of the original Mercury-era trend charts with rear projection panels. These backlit screens were first used during MA-9, the last mission of the Mercury program. The left rear projection screen has dimensions of 8' x 8'; the right is 8' x 10'. No identifying tags were observed on the two inventoried screens. The left rear projection screen has a plate labeled "Jones Machine Co. Steel and Supplies, Merritt Island." Strips of adhesive tape are attached to each screen surface (**Photo 13**). While unverified, it is probable that the tape was used to affix the "show" display charts that are now part of the ESE exhibit. Three backlit panels, incorporated into the ESE exhibit since 1999, are listed in the NASA Custodian Account Property Report for 1997. Model No. 1A88400-1 was manufactured by the McDonnell Douglas Corporation; Models 75M15802 and 75M15803 were manufactured by KSC. [Note: The original trend charts are no longer extant, and ACI's informants were unable to provide information about their disposition.]

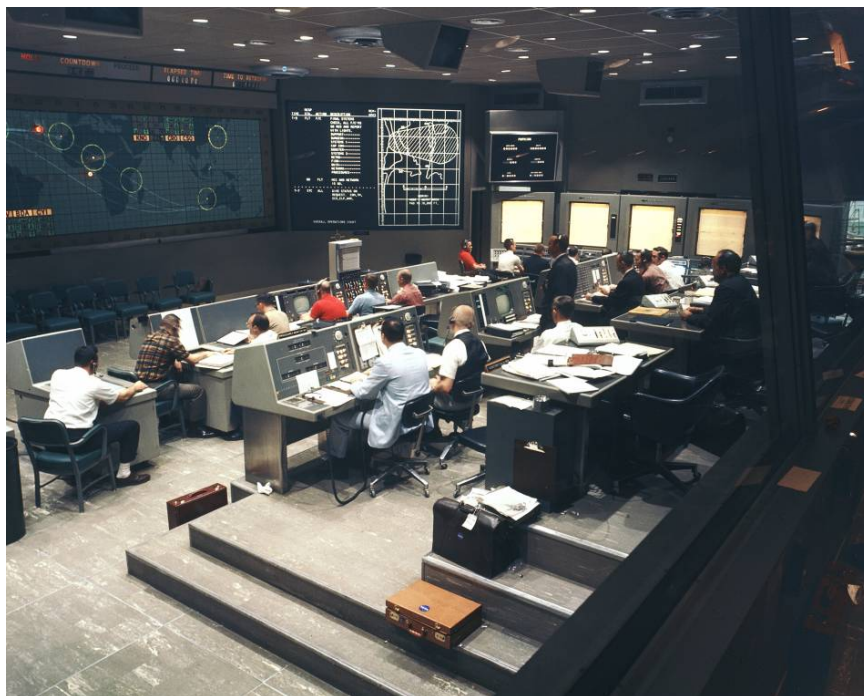
Photo 6. Mission control room during Gemini (I or II) mission, 1964

(Source: NASA KSC-64C-861). *Note the five plot boards and rear projection panels. Also note the elevated platforms supporting the second row of consoles, and the rear row of desks, plus floor covering and ceiling light pattern.*

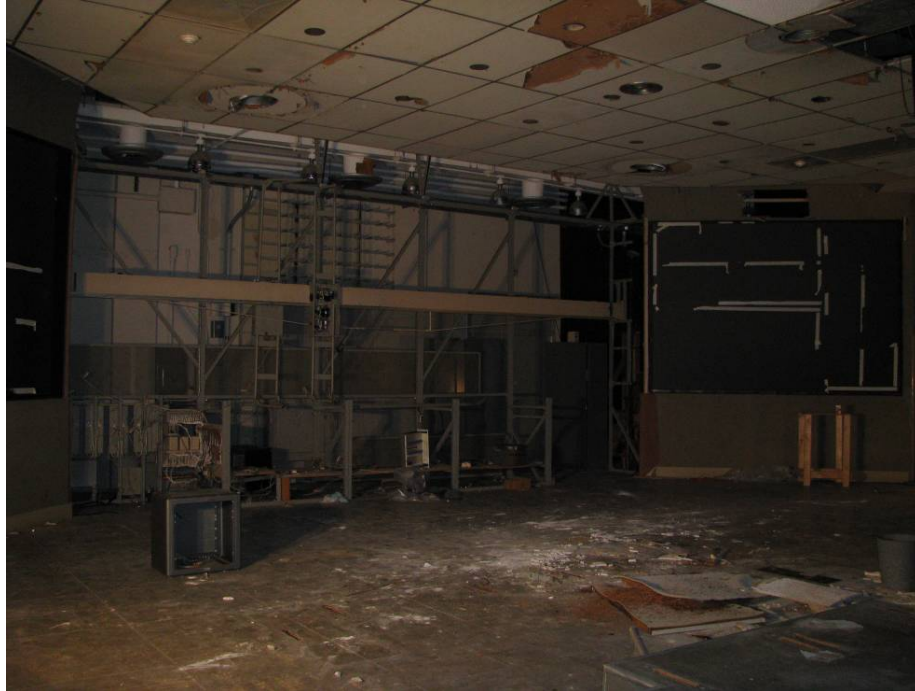
Photo 7. Looking west, northwest across the mission control room, March 2009
 (Source: ACI Photo 13, March 2009). *Not the overall support structure for the world map, the rear projection panels, floor covering, and ceiling light pattern.*

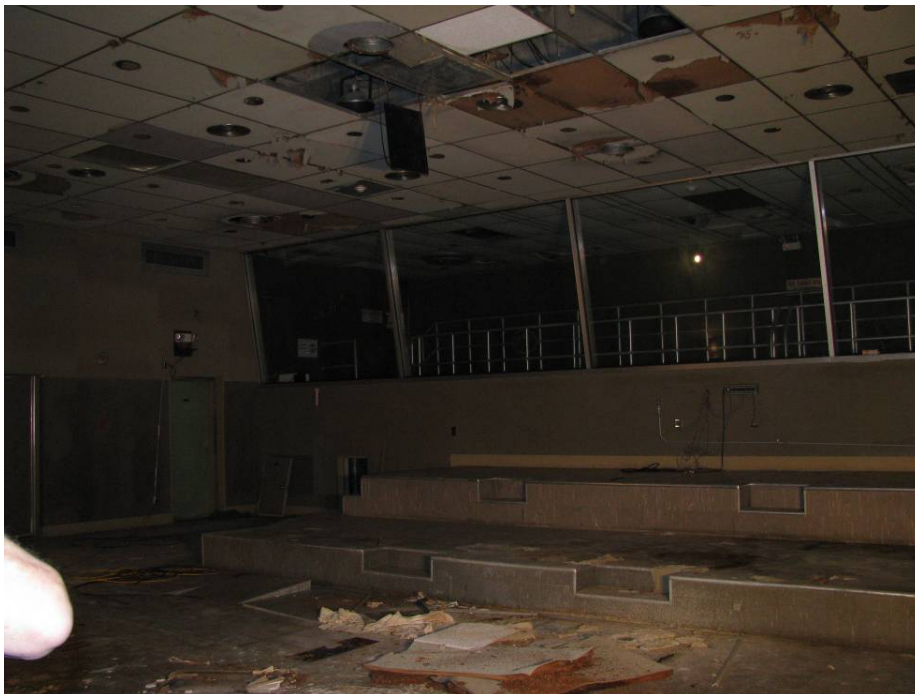
Photo 8. Looking east-northeast across the mission control room, March 2009
 (Source: ACI Photo 47, March 2009). *Note the slanted glass partition and floor platforms. Railings in Viewing Area are non-historic features constructed for the MCC visitor's tour.*

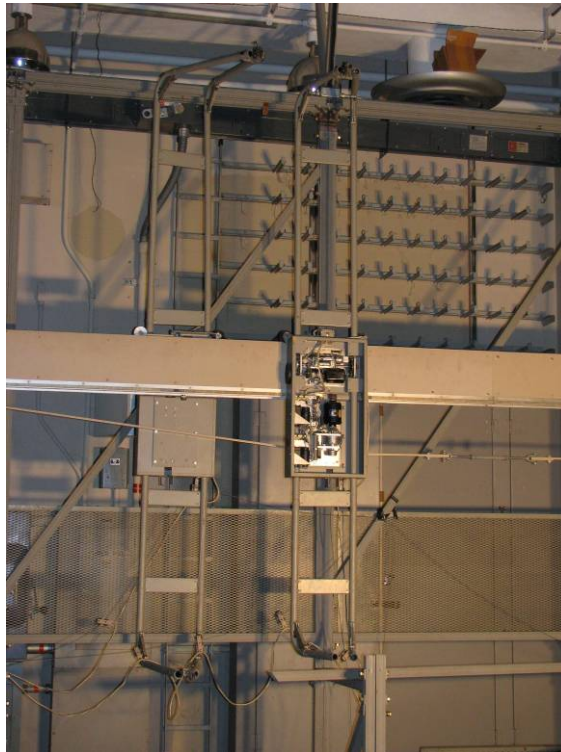
The two sliding arms/tracks (**Photo 9**) are located in the front (west side) of the Flight Control Area. There are two horizontal tracks that are mounted back-to-back and extend for the entire length of the map. The tracks allowed the sliding arms to move “east to west” along the map. Attached to each track is a moveable arm, one of which held a model capsule, on the control room side, the other, on the support area side, a small dot to indicate the landing site. (Videos of the Mercury missions depict the models as flat and red in color. The ESE exhibit displays a black 3-D model of the capsule only.) The arms are attached to their respective track through a motor box (**Photo 10**) that controlled the movement of the arm horizontally along the track, and the capsule/dot vertically along the pulley system. (The pulley system is no longer intact.) The original light harnesses that illuminated the tracking stations (circles) and other features of the world map are still extant, and located behind the original world map on display at the ESE exhibit.

Photo 9. World map sliding arm mechanisms, looking west
(Source: (ACI Photo 33, March 2009).

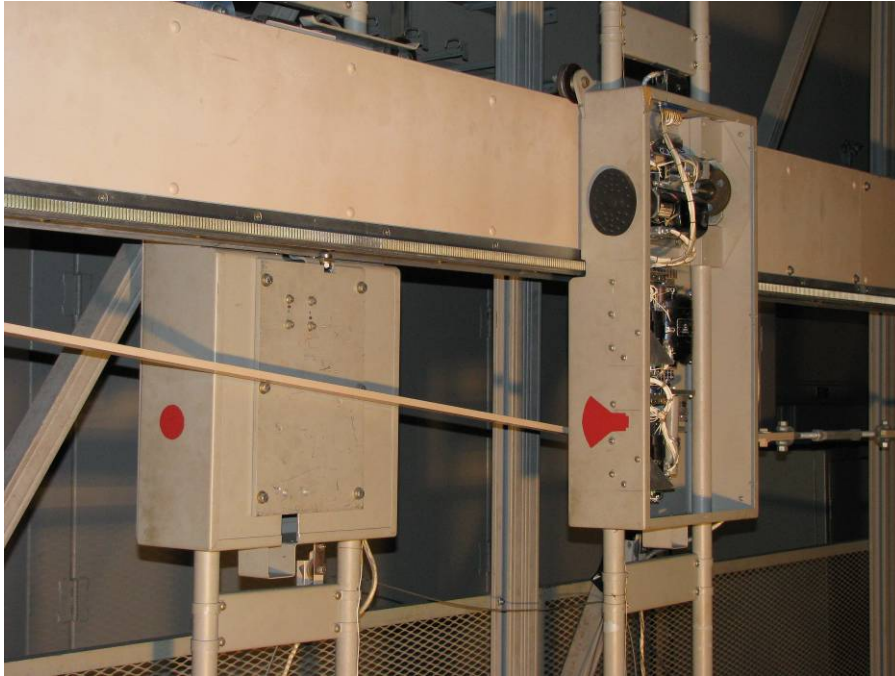
Photo 10. Detail of motor box for world map sliding arm mechanisms, looking northwest
(Source: ACI Photo 46, March 2009).

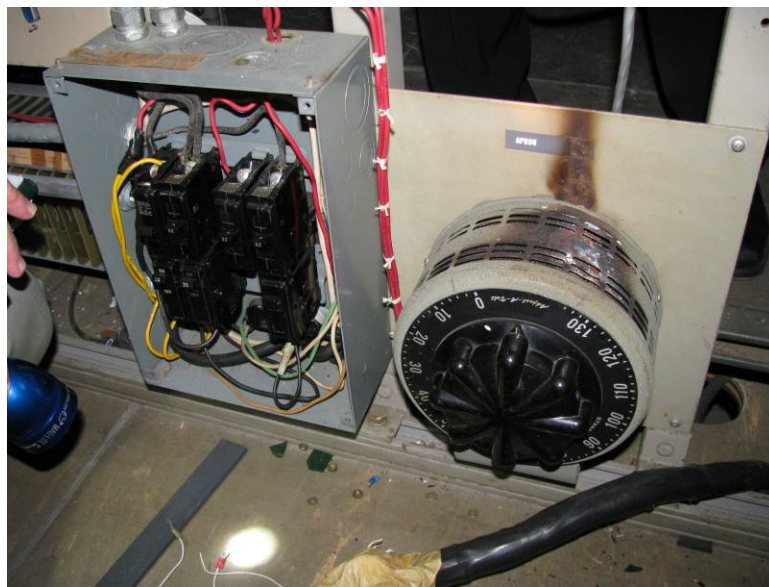
The electrical panel for the world map sliding arms sits at the base of the partition towards the south end. Its accompanying rheostat (**Photo 11**), which regulated electrical currents, is located to the rear of the control panel in the Support Area.

Photo 11. Rheostat for world map operation, looking northeast
(Source: ACI Photo 21, March 2009).

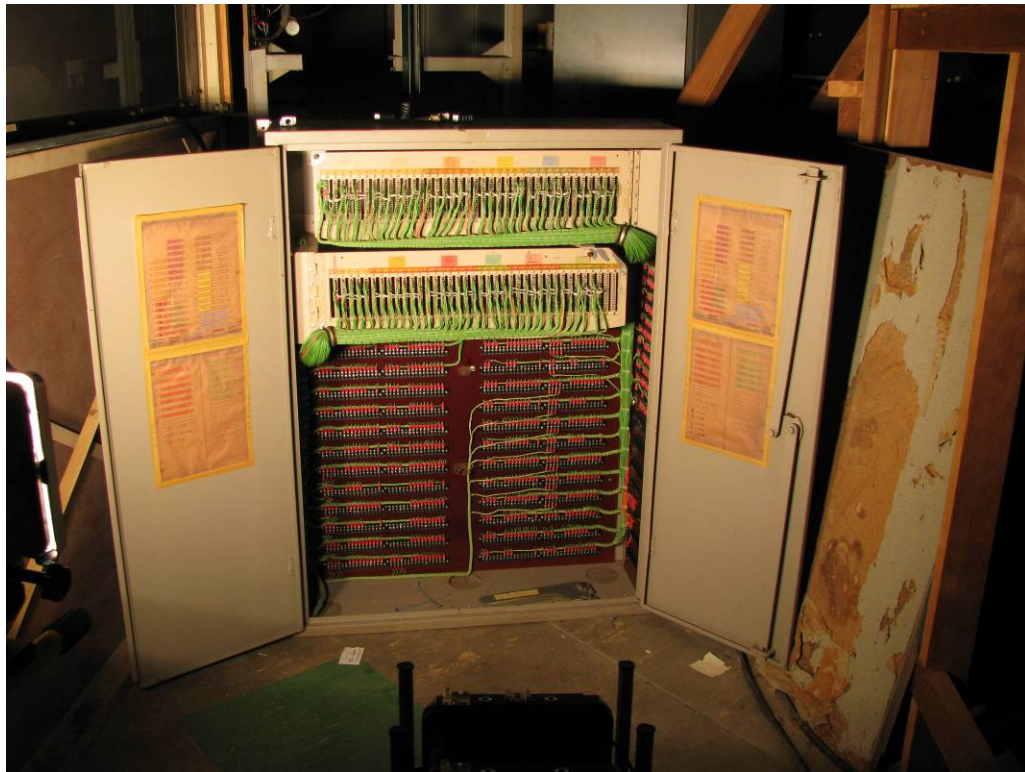
This artifact is a large, free-standing electrical cabinet (**Photo 12**) that is currently sitting in the northwest area of the Support Area. The top third of the cabinet contains two series of push connectors; the lower two-thirds contain screw connectors. It retains much of its original bundled wiring, as well as hand-written notes. The notes suggest that this cabinet may have supported the time displays above the world map. A plate along the front above the doors indicates that the shell was supplied by Jones Machine Company; the wiring was most likely done by Stromberg-Carlson, as implied in documents prepared by Western Electric Company, Inc. (Western Electric Company, Inc. 1960: Table 2-3).

Photo 12. Electrical cabinet located in the Support Area, looking southwest
(Source: ACI Photo 48, March 2009).

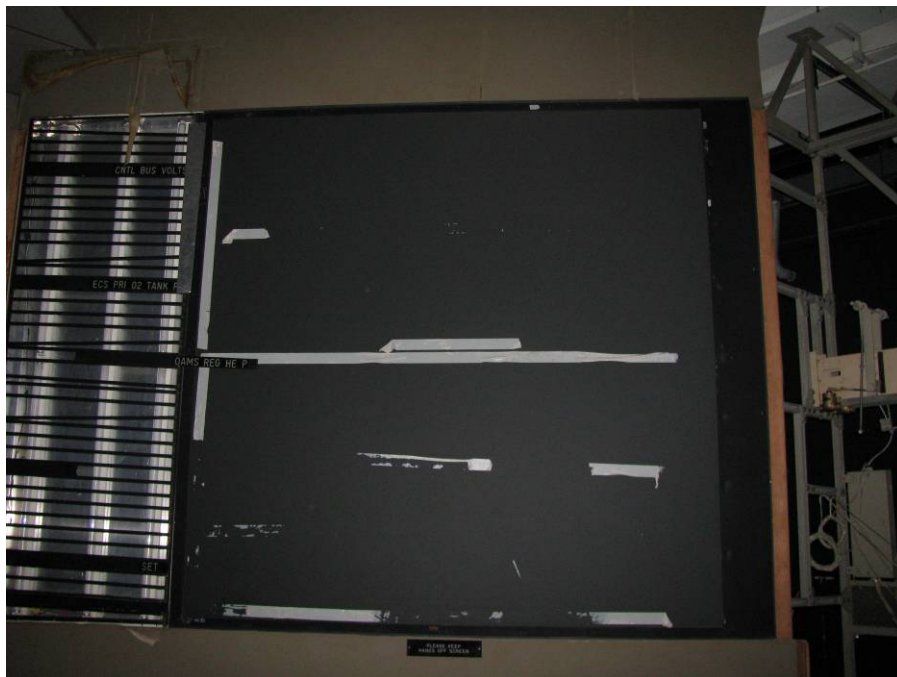
Photo 13. Rear projection screen to left side of world map, looking southwest

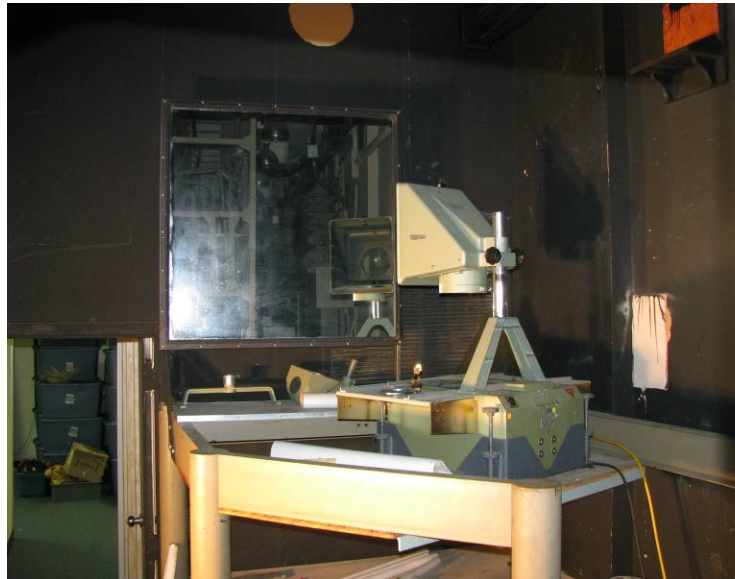
The projector (**Photo 14**) is located atop a metal and wooden platform in the southwest corner of the Support Area. While not original to Project Mercury, its location is depicted in the architectural plans for the 1962-1963 building modifications, thus suggesting its use during the Gemini program (NASA LOC 1964:A-1). The projector is stamped with the date 1/13/61, and labeled with this information: “Model C6831, Projection Optics Co., Inc., N.J. Distributed by Technifax Corporation, Bendix Corporation.” It is tagged with the NASA ECN #653711. According to the NASA Custodian Account Property Report for 1997, the projector was manufactured by James River Graphics Tech. The projector’s companion mirror, which measures approximately 4’ x 4’, is mounted to the south wall. This mirror directed the images on the projector to the rear projection panel.

Photo 14. Projector and mirror located in the Support Area, looking southwest (Source: ACI Photo 44, March 2009).

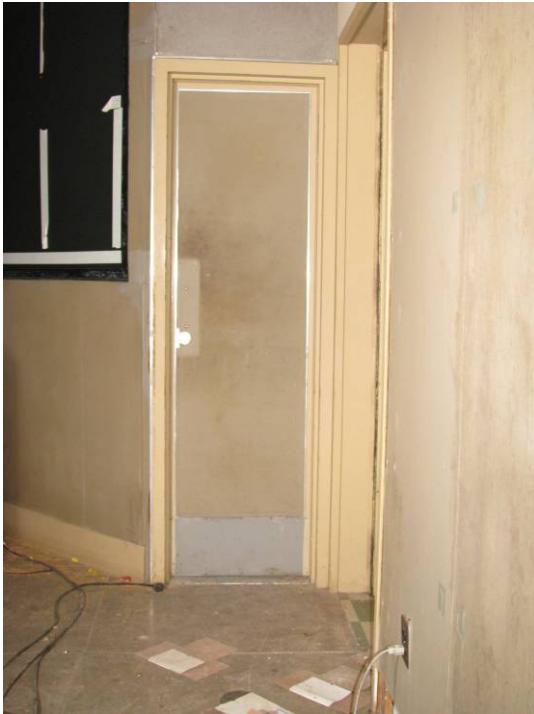
Two wood doors with brass handles, which flanked the Mercury-era trend charts, provided access between the Flight Control and Support Areas. The aluminum trim around each door and door surround (**Photo 15**) is the same architectural design feature used along the Flight Control Area walls. A small door of similar design (**Photo 16**) is located along the east wall near the northwest corner of the room. This door provided access to the cabling tunnels beneath the Raised Viewing Area.

Photo 15. Door to right of the world map, looking west (Source: ACI Photo 18, March 2009).

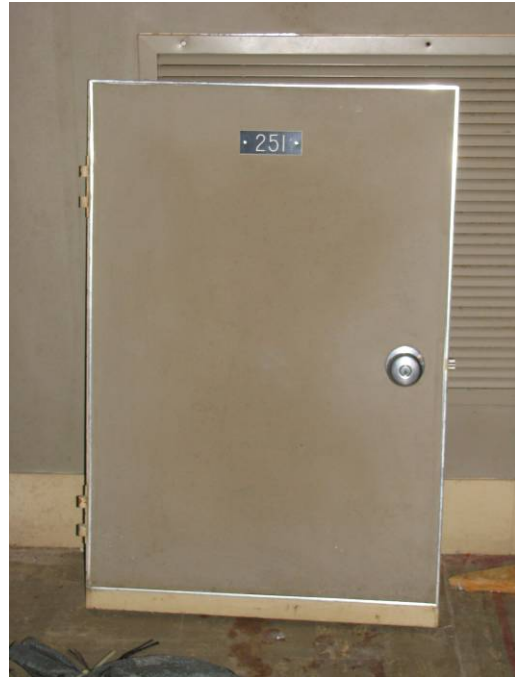
Photo 16. Small door near northeast corner of Room 253, looking east (Source: ACI Photo 20, March 2009)

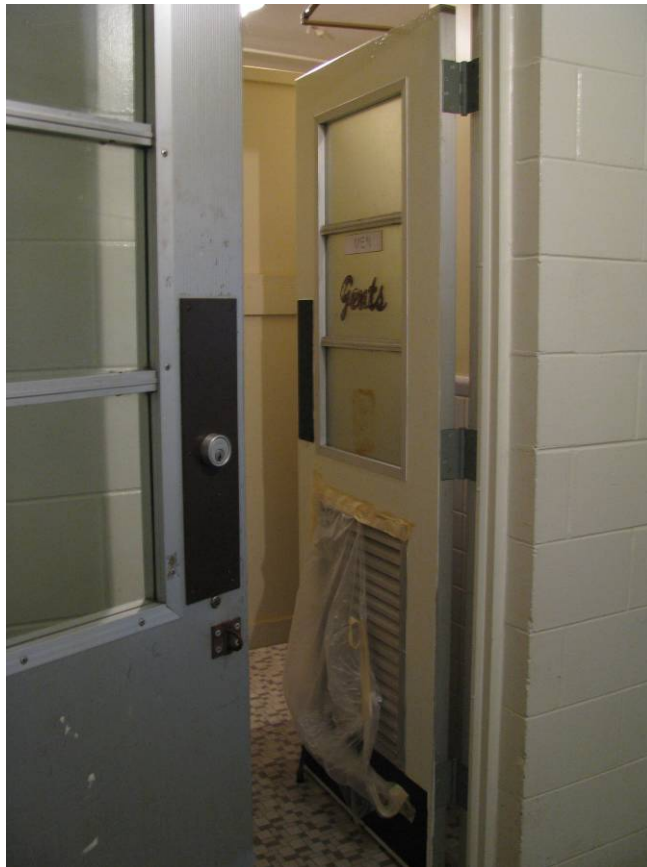
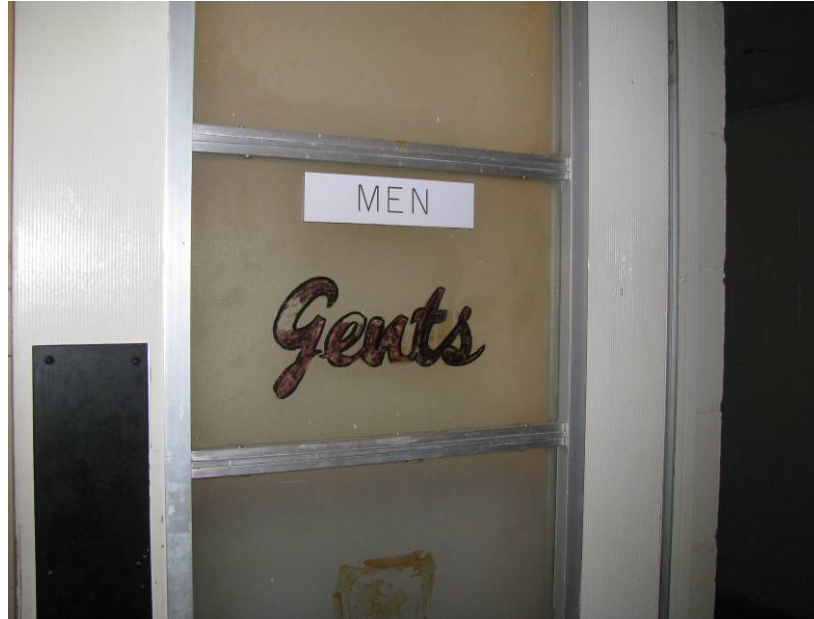
The men's restroom is located to the southeast of the historically significant portion of the MCC. The door to the "Gents Room" (**Photos 17 and 18**) is 2'-6" wide by 7'-0" high. It is composed of a wood core with aluminum facing, and dates to the original building. In the upper half are three glass panes with aluminum frames, stacked vertically; the center pane contains an applied "MEN" sign (similar to the room number signs), as well as a hand painted "Gents." The lower half of the door contains an aluminum ventilation louver.

Photo 17. Door to men's bathroom, facing northeast
(Source: ACI Photo 9, March 19, 2009).

Photo 18. Detail of men's bathroom door front, facing northeast
(Source: ACI Photo 41, March 4, 2009).

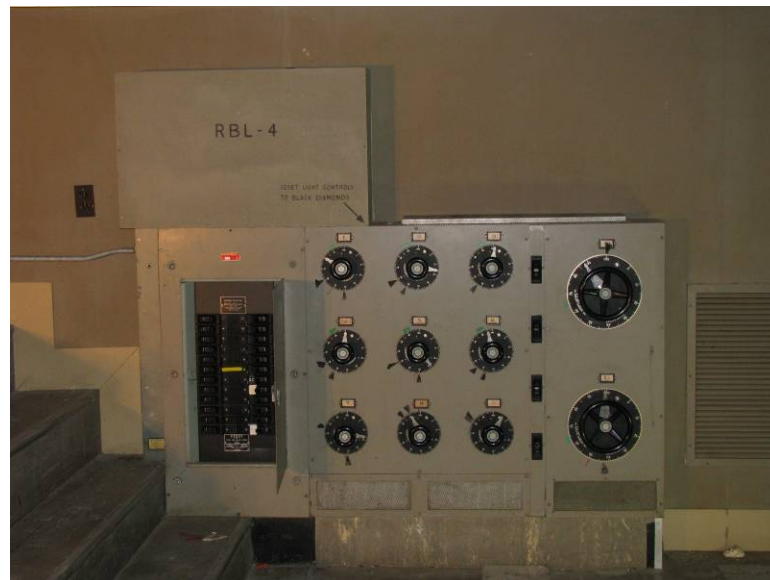
A large electrical panel (**Photo 19**) is located along the east wall of Room 253, near the south end. This panel provided the controls for the lighting throughout the Flight Control Area, either through the circuit breakers (to the left) or the dimmer controls (knobs to the right).

Photo 19. Electrical panel at the rear of Room 253, looking east
(Source: ACI Photo 36, March 2009).

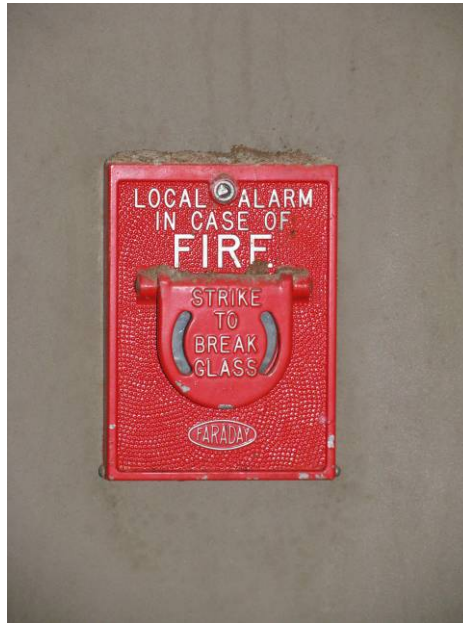
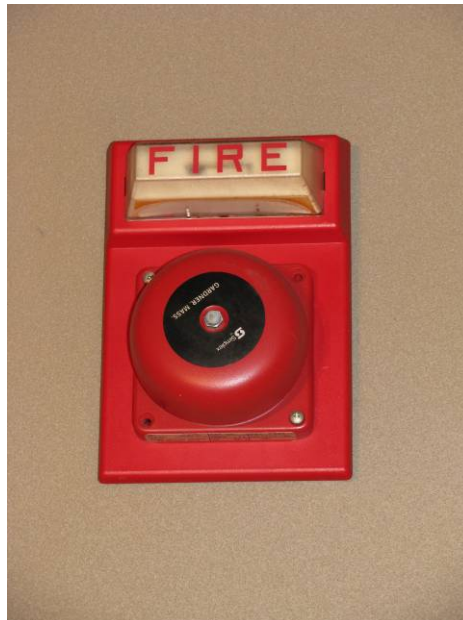
These artifacts (**Photos 20 and 21**) are located on the north wall of Room 253. The alarm pull was manufactured by Sperti Faraday, Inc. of Adrian, Michigan; the fire bell was made by Simplex in Gardner, Massachusetts. The alarm pull may be associated with the bell previously salvaged by Fisher and Gruenbaum (Artifact # 1507).

Photo 20. Fire alarm pull located on the north wall of Room 253, looking north
(Source: ACI Photo 21, March 2009).

Photo 21. Fire alarm bell located on the north wall of Room 253, looking north
(Source: ACI Photo 28, March 2009).

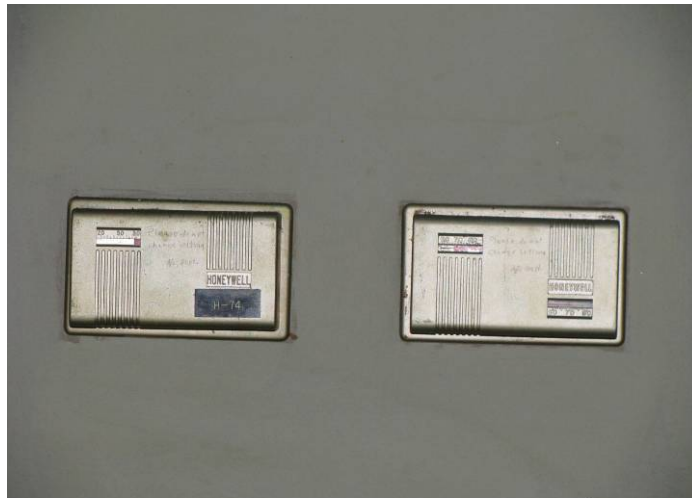
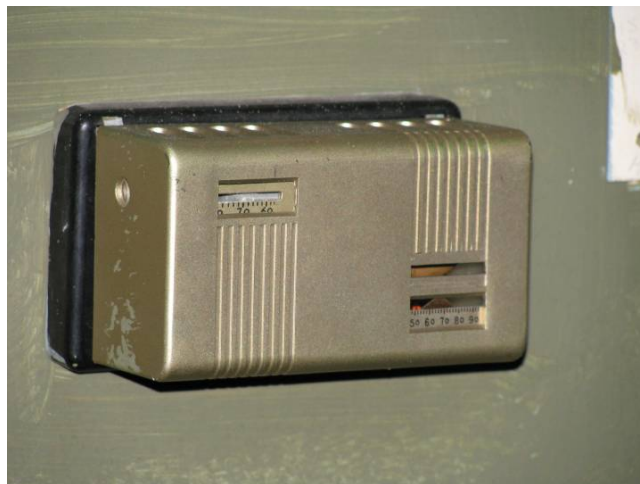
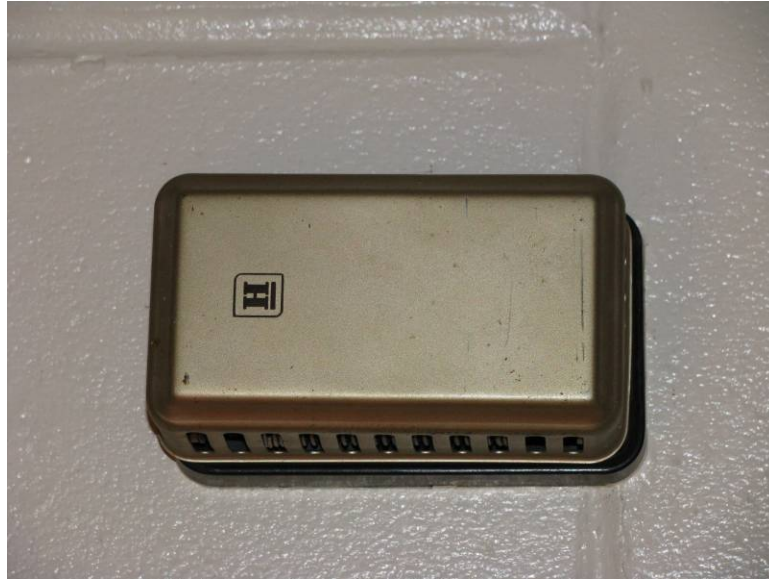
Two thermostat boxes, manufactured by Honeywell, are located side-by-side on the south wall of the Flight Control Area (**Photo 22**), and another of the same model (**Photo 23**) is located on the south wall of the Raised Viewing Area. Another two, also by Honeywell, are located along the north wall of the Raised Viewing Area and the north wall of Room 222 (**Photo 24**). These two are identical to the gold-painted covered metal boxes (Artifact #'s 1505 and 1506) salvaged and catalogued by Fisher and Gruenbaum in October 2008, and currently in storage in Room 2427 of the Public Affairs Office at the KSC Visitor Complex. These artifacts measure approximately 5" high x 3" wide x 2-1/2" in depth.

Photo 22. Location of two thermostat boxes on south wall of the Flight Control Area, looking south (Source: ACI Photo 108, March 2008).

Photo 23. Detail of thermostat box on south wall of Raised Viewing Area, looking south (Source: ACI Photo 134, March 2009).

Photo 24. Thermostat box in Room 222, looking north
(Source: ACI Photo 120, March 2009).

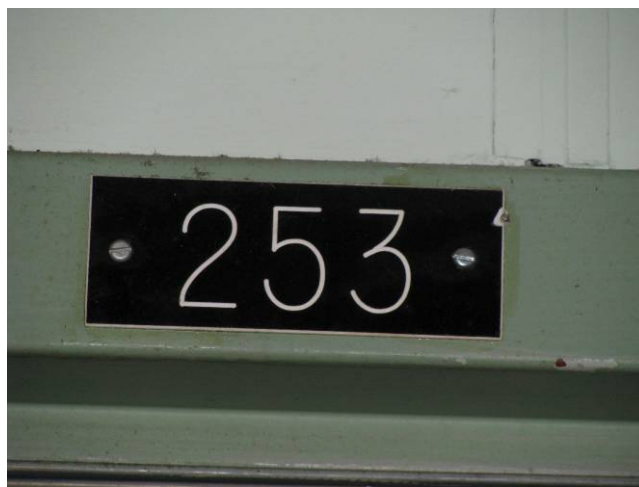
Numerous metal plate room number signs were observed in the MCC. However, only those associated with the historically significant rooms were inventoried. Of the total ten room number signs, two designate Room 253. One of these is located above the door on the south wall of Room 223 (**Photo 25**), and the other is on the north wall of Room 230.

Photo 25. Sign for Room 253, looking south
(Source: ACI Photo 116, March 2009).

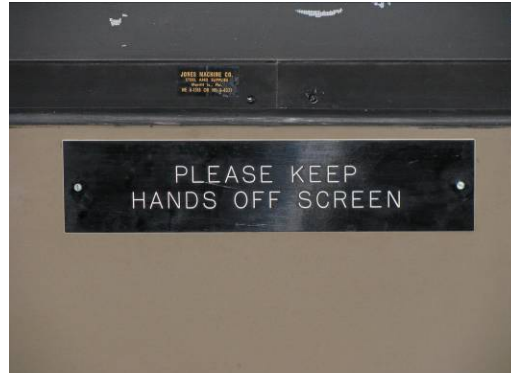
This metal sign (**Photo 30**) is located below the left rear projection screen.

Photo 30. Sign located below left screen of the world map, looking southwest
(Source: ACI Photo 109, March 2009).

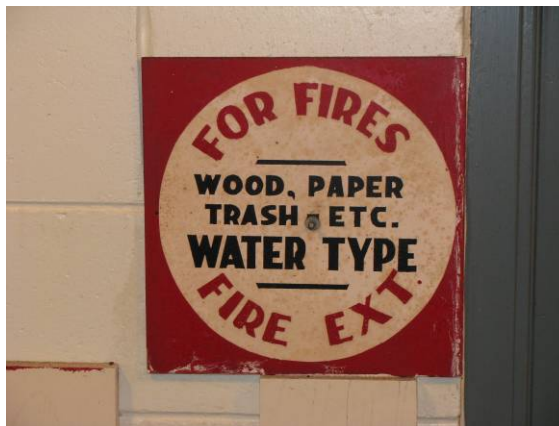
This painted fire extinguisher sign (**Photo 31**) is located along the west wall of the former Gemini Training Room (Room 213), across the corridor from the Raised Viewing Area. The roughly square ¼” masonite sign measures 12” high by 11-3/4” wide. This artifact, “the last remaining sign of its kind” (Fisher 2009), is identical to Artifact #1509 (**Appendix A**) that was salvaged and catalogued in October 2008 by Fisher and Gruenbaum, and which is stored in Room 2427 of the Public Affairs Office at the Visitor Complex. It is also similar in overall design to another salvaged “For Fires Fire Ext.” sign (Artifact #1508) marked “Electrical Gasoline Oil Paint – Etc Carbon Dioxide” in black letters on a beige field.

Photo 31. Fire extinguisher sign located in Room 213, looking west
(Source: ACI Photo 141, March 2009).

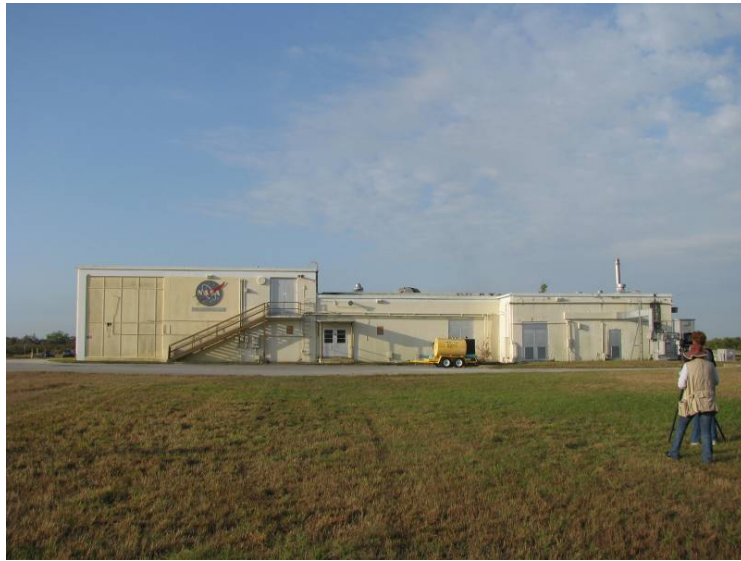
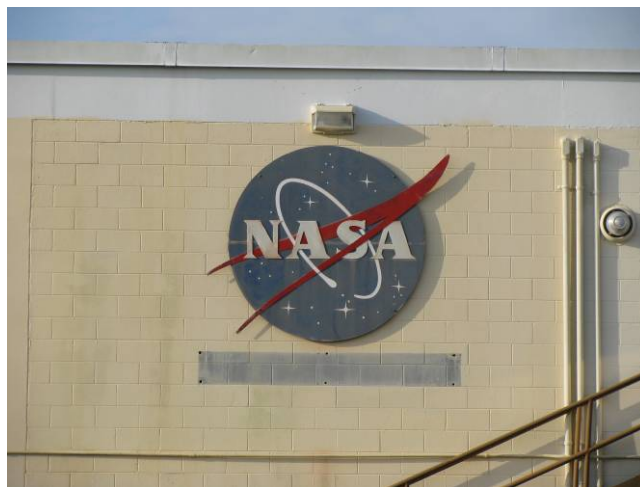
The NASA “meatball” logo, composed of a sphere, orbit, red chevron, and stars, was first designed in 1959. Three meatball logo signs are affixed to the north (**Photos 32-33**), south, and east (**Photo 34**) elevations of the MCC building. None is original. When compared with the design of the logo in place on the MCC in 1962 (**Photo 35**), the differences are evident. According to Doug Fisher (2009), the sign on the east elevation is the most like the original. Reportedly, the three meatball logo signs were installed “for show.” The date or dates of placement on the building was(were) unknown by the KSC and Delaware North informants.

Photo 32. View of NASA “meatball” logo sign on north elevation of the MCC, looking south (Source: ACI Photo 5, March 2009).

Photo 33. Close up view of “meatball” logo sign along north elevation of the MCC, looking south (Source: ACI Photo 6, March 2009).

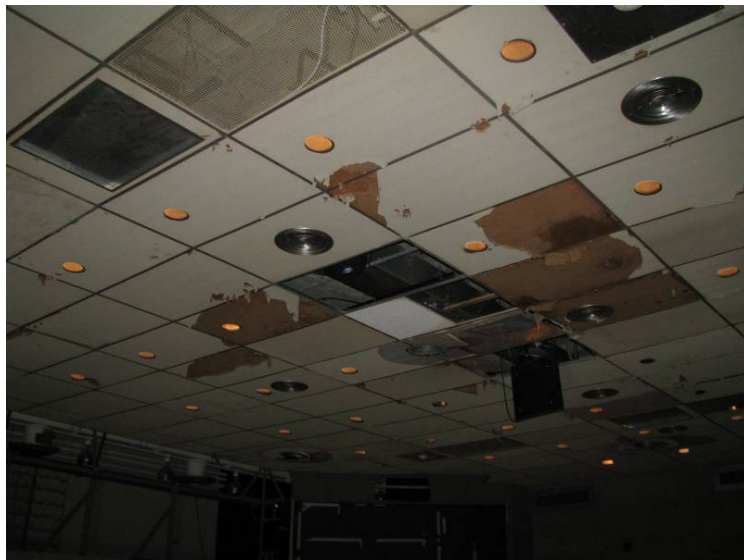
A few remaining ceiling-mounted audio speakers were observed in Room 253. A partial view of the remaining speakers is shown in **Photo 36**. The speaker cover plate (**Photo 37**) consists of a brushed aluminum assembly of nested concentric metal rings; the overall size is approximately 15-1/2" in diameter. They are Slimline High Fidelity speakers manufactured by Stromberg Carlson of San Diego, California. The speaker cover plate illustrated in Photo 37 is identical to Artifact #'s 1515, 1558, 1559, 1560, and 1561 previously removed by Fisher and/or Gruenbaum in October 2008. These catalogued artifacts are currently stored in Room 2427 of the Public Affairs Office at the KSC Visitor Complex.

Photo 36. Pattern of ceiling audio speakers in Room 253

(Source: ACI Photo 103, March 2009). *Also note the locations of recessed ceiling lights.*

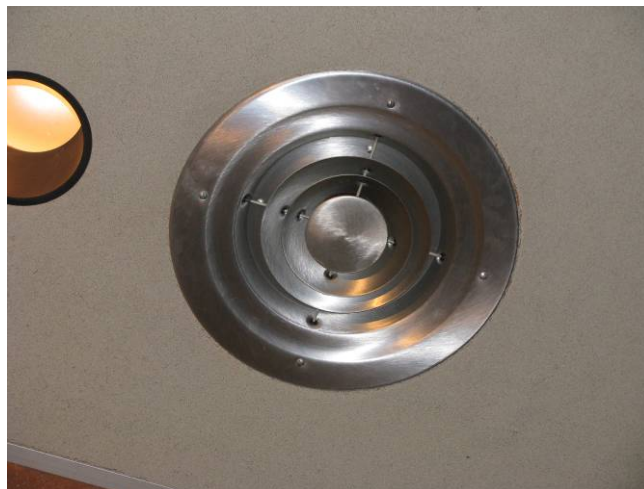
Photo 37. Small ceiling-mounted audio speaker cover plate

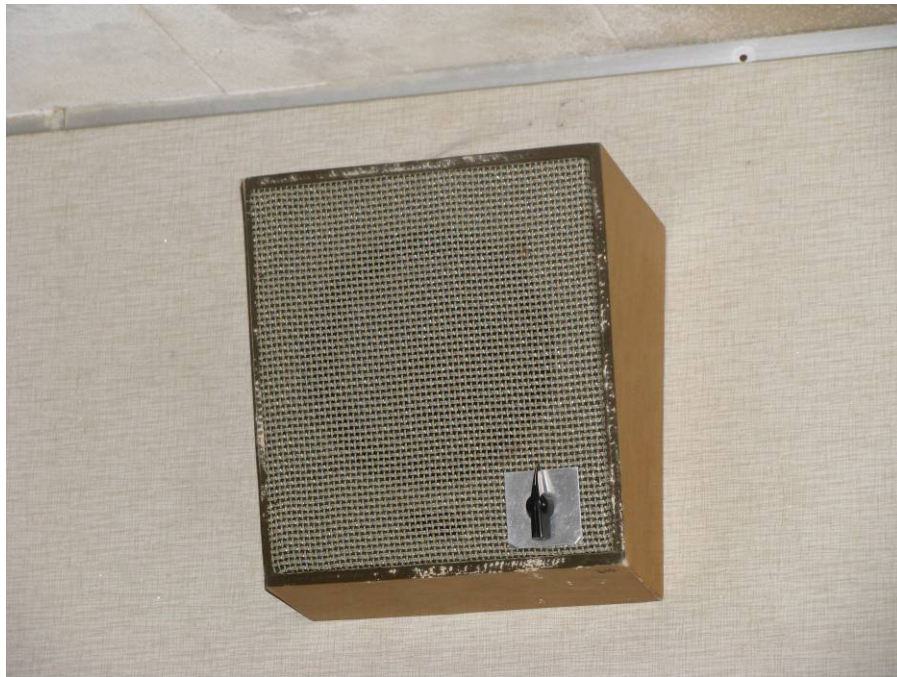
Five wall-mounted speaker boxes, elements of the original Western Electric intercom system, were identified in Rooms 221 (1), 222 (3), and 223 (1). The wood boxes are faced with fabric covering, and feature a control knob at the lower right (**Photo 38**). Each measures approximately 11" high x 10" wide x 6" deep. These artifacts are identical to the three speaker boxes removed from the MCC by Fisher and Gruenbaum in October 2008. These three were assigned the Artifact #'s 578, 1511, and 1512 (see **Appendix A**). Artifact # 578 was installed in the ESE display at the KSC Visitor Complex; #'s 1511 and 1512 are being stored in Room 2427 of the Public Affairs Office.

Photo 38. Intercom speaker box located in Room 223
(Source: ACI Photo 117, March 2009).

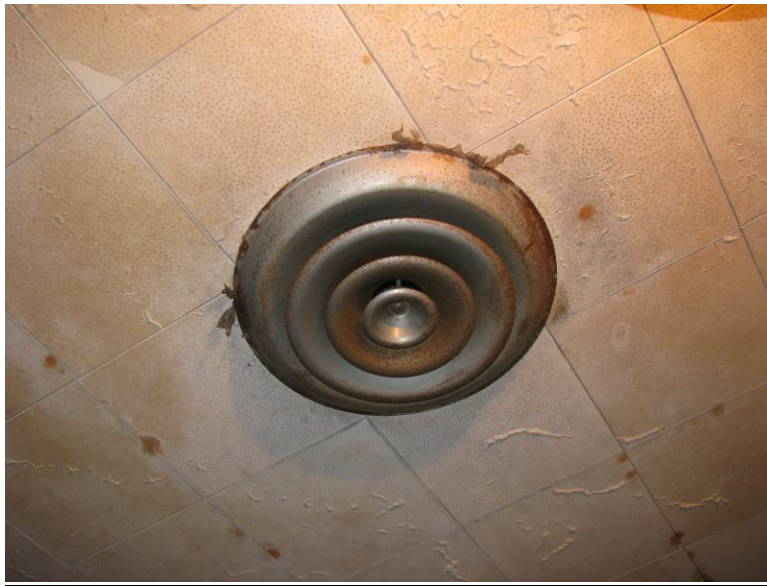
According to the “Reflected Ceiling Plan” drawings (Burns and Roe, Inc. 1959:24), a total of eight HVAC diffusers were originally located in the Flight Control Area. All have been removed. Two of the removed artifacts were catalogued in 2008 as Artifacts #1556 and 1557 (**Appendix A**); they are currently in the Delaware North exhibit storage cage. These silver-painted, formed metal diffusers are composed of two parts: an outer circle and a center composed of three concentric rings. Identical to the two salvaged artifacts are eight HVAC diffusers identified by ACI in Rooms 221 (4) and 223 (4). A representative artifact is depicted in **Photo 39**.

Photo 39. HVAC diffuser in Room 221, looking northwest
(Source: ACI Photo 124, March 2009).

The recommendations for artifact salvage take into consideration the totality of previously collected materials. For example, the Flight Control Area originally had eight HVAC diffusers mounted to the ceiling tiles, of which two have been removed, catalogued, and stored. Thus, salvage of six to eight remaining HVAC diffusers would enable recreation of the pattern of HVAC fixtures across the mission control room ceiling using original materials. The same approach was applied to the recommended retention of audio speaker assemblies.

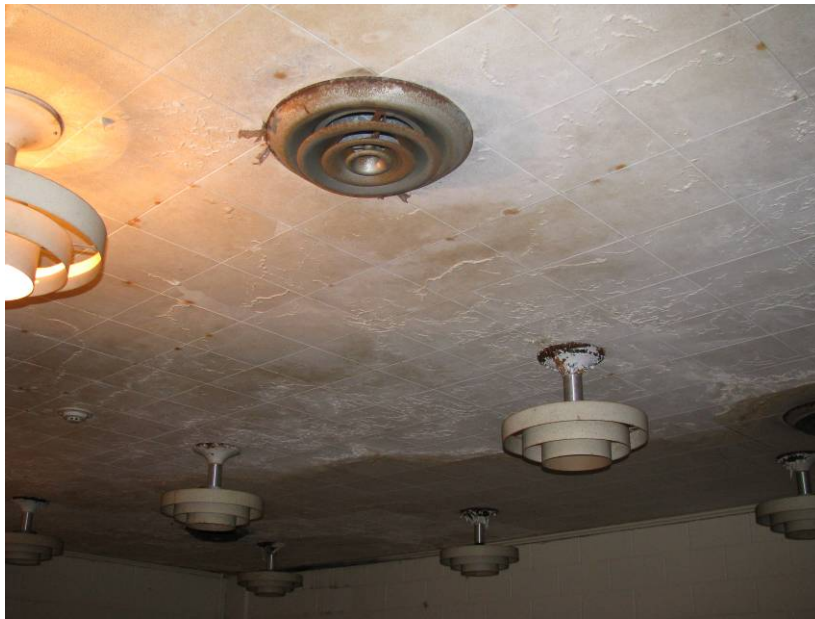
The majority of ceiling light fixtures remaining in Room 253 are generic, recessed “can” lights. The original engineering drawings (Burns and Roe, Inc. 1959:24) indicate a grid pattern of 58 lights. The historically significant portions of the MCC, as well as adjacent rooms and corridors, contain a variety of lighting fixture types, including pendant lights and glass globes. Specifically, a total of 15 pendant lights, characterized by three tiers of concentric circles in graduated sizes, were identified in Room 221 (9) (**Photo 40**) and 223 (6). Frosted glass globe lights in several shapes were also identified along the corridors (**Photo 41**).

Photo 40. Pendant lights in Room 221
(Source: ACI Photo 126, March 2009). *Also note HVAC diffuser.*

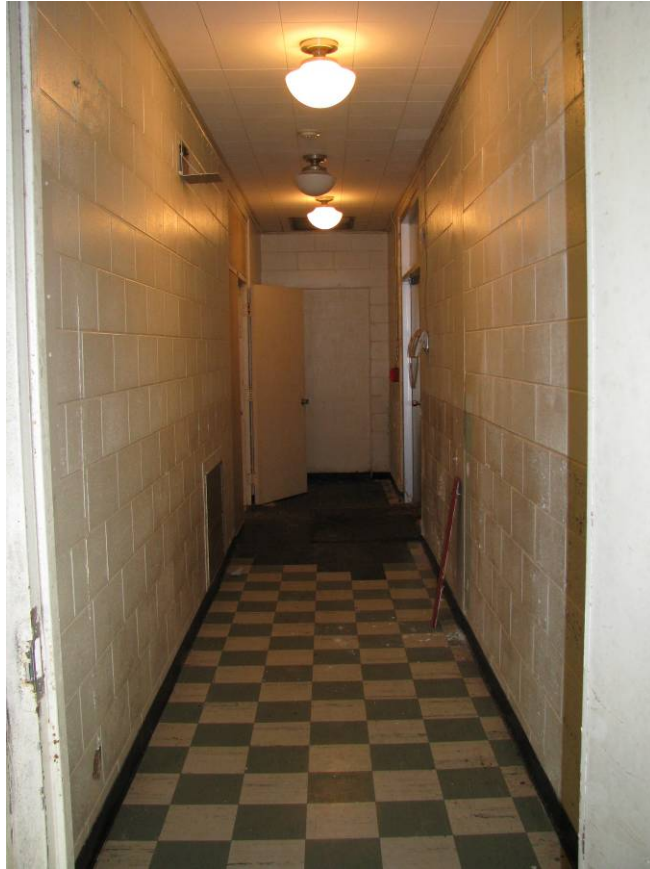
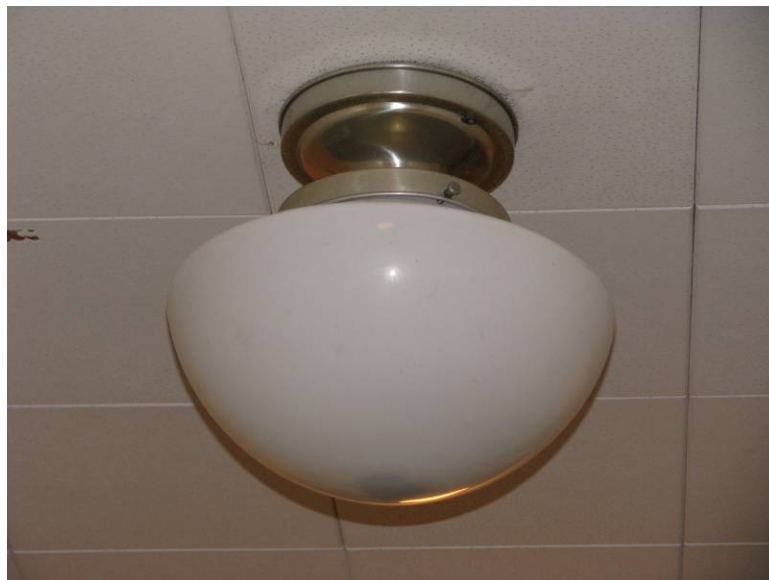
Photo 41. Globe lights in 221A corridor near Rooms 221 and 222, looking west
(Source: ACI Photo 64, March 2009).

Photo 42. Close-up of center globe light in 221A corridor, looking west
(Source: ACI Photo 63, March 2009).

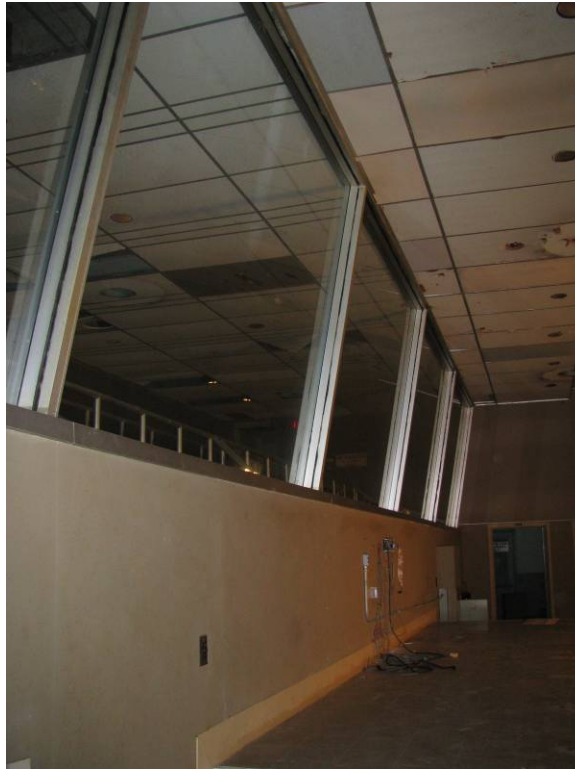
Photo 43. Slanted glass window partition, looking south
(Source: ACI Photo 24, March 2009).

While unquestionably a distinguishing feature of the historic mission control room and adjacent viewing area, the slanted glass partition, in its entirety, is not recommended for salvage. The ¼" glass panes are commonly available, and can easily be replaced in-kind. However, if inspection of the framing indicates that it is not gasketed, and, if feasible, the framing system is recommended for salvage, storage, and possible interpretive use in an interpretive exhibit.

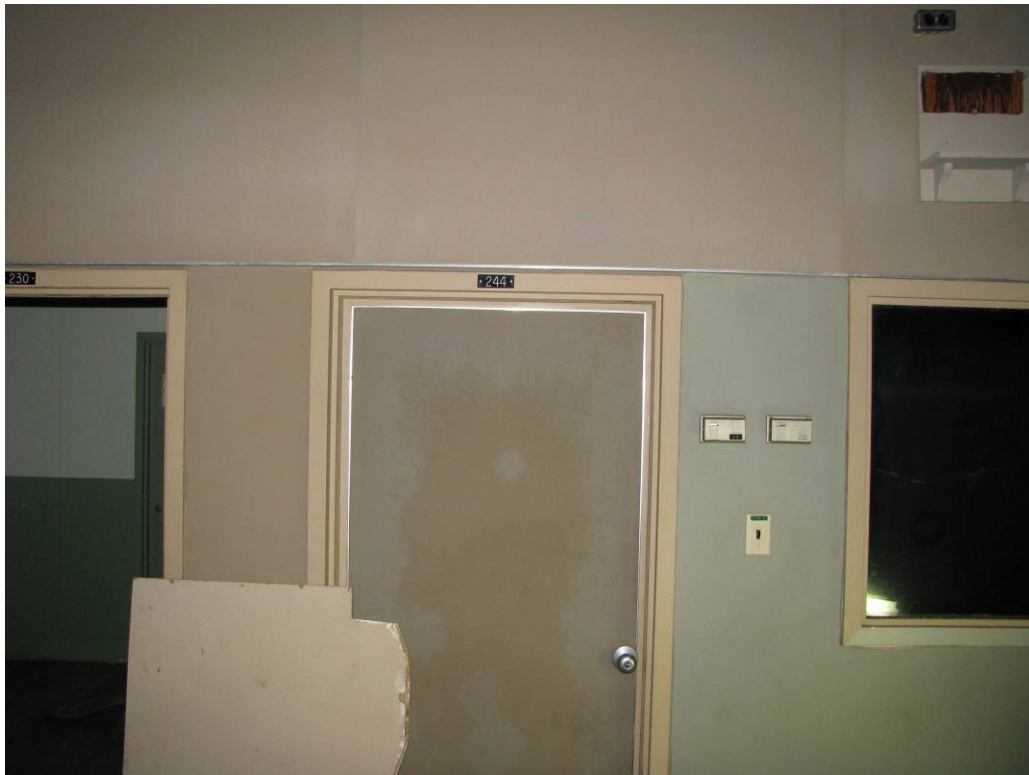
The north and south walls of Room 253 are covered with two different finishes, separated by a thin aluminum strip. The architectural plans specified Vicrtex Stip-L-Text, V275, in desert tan (Color 2111) for the lower half of the walls, and ¼-inch thick Curon covering in smoke gray (Color 1025) for the upper walls (Burns and Roe, Inc. 1959: Sheet 22). No documents confirming the use of these specific finishes could be found, and a high degree of deterioration renders it impossible to determine the original colors. The aluminum strip also is used as a trim around the two doors at the west side of the Flight Control Area (cf. Photo 15).

Photo 44. South wall of the Flight Control Area showing wall coverings and aluminum strip, looking south (Source: ACI Photo 106, March 2009).

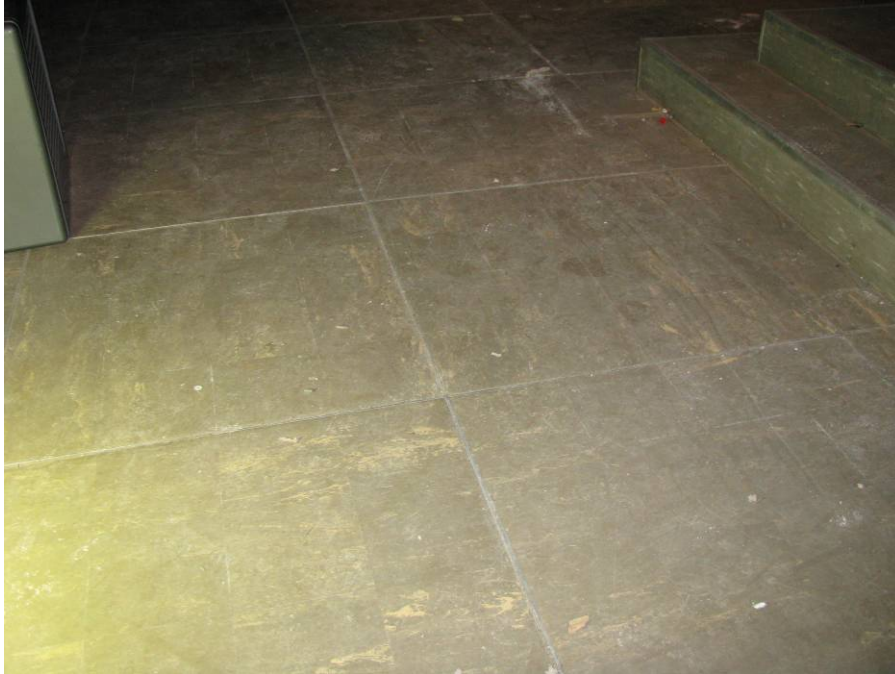
The raised floor of Room 253 is composed of removable panels, which were to be covered with 1/8" thick, ash taupe-colored, rubber tile (**Photo 45**) manufactured by the Armstrong Cork Company, as specified on the architectural plans (Burns and Roe, Inc. 1959: Sheet 22). No documentation confirming the use of these specific tiles could be found. The removable panels measure roughly 4' x 3', and have an aluminum edging.

Photo 45. Floor tile in the Flight Control Area, looking west
(Source: ACI Photo 101, March 2009).
